NASA/TM-2005-213519

Dynamic Response of X-37 Hot Structure Control Surfaces Exposed to Controlled Reverberant Acoustic Excitation

Ferdinand W. Grosveld

This document represents a compilation of three informal reports from reverberant acoustic tests performed on X-37 hot structure control surfaces in the NASA Langley Research Center Structural Acoustics Loads and Transmission (SALT) facility. The first test was performed on a carbon-silicone carbide flaperon subcomponent on February 24, 2004. The second test was performed on a carbon-carbon ruddervator subcomponent on May 27, 2004. The third test was performed on a carbon-carbon flaperon subcomponent on June 30, 2004.

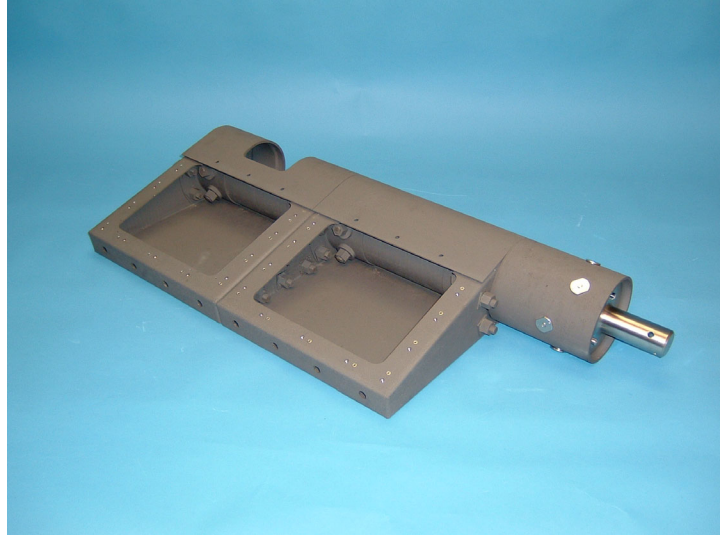
The C/SiC Flaperon subcomponent test article consists of carbon-silicone carbide (C/SiC) composite materials fabricated by GE Power Systems Composites (GE PSC). The architecture of all the elements of the Flaperon, including the torque tube, ribs, gussets, and face sheets, is specified as quasi-isotropic layups (0/45/90/-45)_{NS}. A picture of the test article with the access panel removed is shown in Figure 1-1.

Figure 1-1: Picture of the test article with access panel removed.

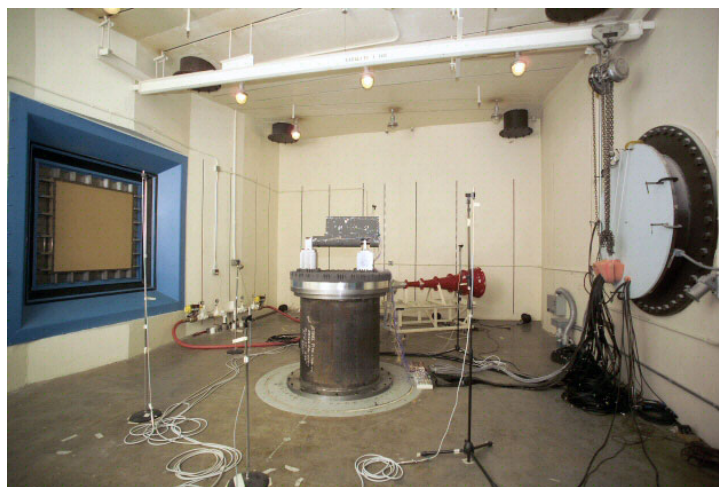
The 9800 ft³ SALT facility reverberation chamber (Reference 1-1) is structurally isolated from the rest of the building and measures approximately 14.8 ft by 21.2 ft by 31.2 ft. Figure 1-8 shows the reverberation chamber with the instrumented test article mounted on the sand-filled pedestal support. Rigid close-out panels were installed in the transmission loss window (separating the reverberation room from the anechoic chamber) on the left and the flow duct on the right.

Figure 1-8: Test article mounted on the pedestal support structure in the reverberation chamber.

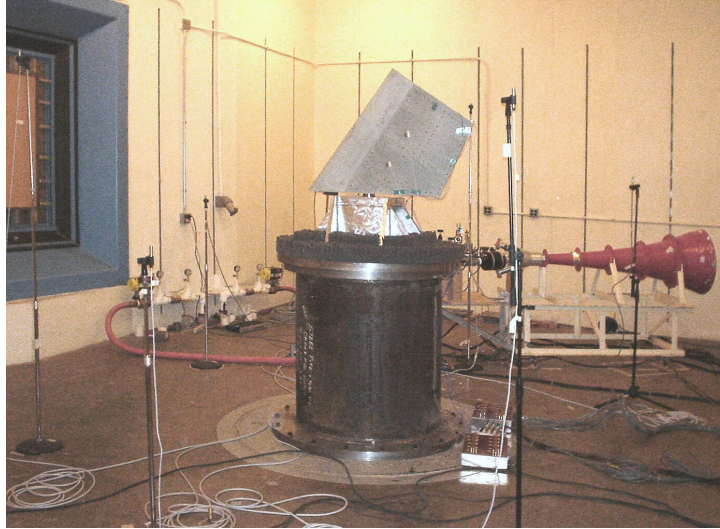
The 9800 ft³ SALT facility reverberation chamber (Reference 2-1) measures approximately 14.8 ft by 21.2 ft by 31.2 ft and is structurally isolated from the rest of the building. Figure 2-8 shows the reverberation chamber with the instrumented test article mounted on the sand-filled pedestal support. Rigid close-out panels were installed in the transmission loss window (separating the reverberation chamber from the anechoic chamber) and the flow duct (not shown in the picture). The chamber walls and ceiling of the reverberation chamber are splayed to diminish the effects of standing waves between opposite surfaces and are separated by a 30-inch air gap from the surrounding 18-inch thick concrete building walls. The total surface area of the walls, floor, and ceiling is approximately 3120 ft². One-third octave band ambient noise levels were measured previously (Reference 2-1) in the reverberation chamber and are listed in Table 2-2. The minimum frequency for a diffuse sound field in the reverberation chamber was calculated to be 83.2 Hz yielding the one-third octave bands with 100 Hz and higher center frequencies exhibiting diffuse sound conditions (Reference 2-1). Table 2-2 also lists the T(20) reverberation times, the estimated times required for the sound pressure level (SPL) to decrease 60 dB, extrapolated from the SPL decays between -5 dB and -25 dB.

Figure 2-8: Test article mounted on the pedestal support structure in the reverberation chamber.

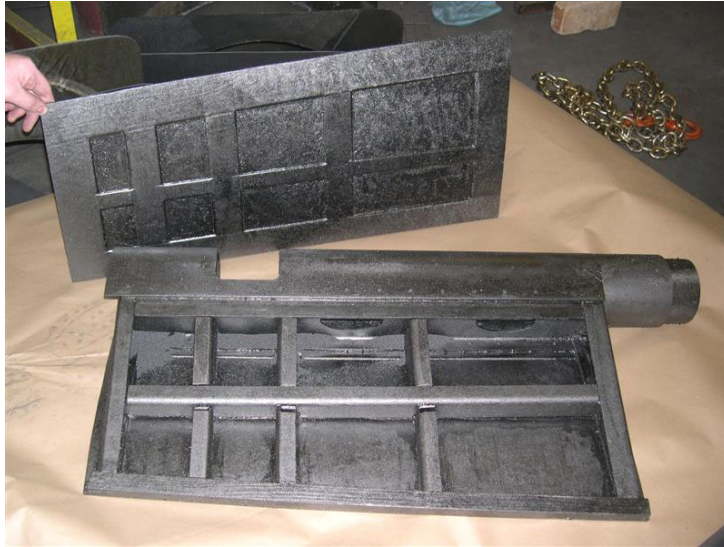
The C-C Flaperon subcomponent test article consists of carbon-carbon composite materials fabricated by Carbon-Carbon Advanced Technologies, Inc. The subcomponent test article (STA) is a truncated full-scale replica of the flight hardware that incorporates all major structural components, such as the torque tube, spindle, hinge pin, and ribs. The test article is a full scale part starting at the inboard edge of the component and including the actual spindle and torque tube diameters. The overall dimensions of the test article are 37 in. long by 18.7 in. wide by 5 in. thick. The C-C Flaperon test article with the access panel removed is shown in Figure 3-1.

Figure 3-1: C-C Flaperon test article with access panel removed.
